IDENTIFYING SEAL DEFECTS AND COCKED CROWNS IN BEER BOTTLES

Tested: 640 Milliliter Glass Beer Bottles with Metal Crowns

Tested with: TapTone 500-AC Acoustic Sensor with Cocked Crown Option

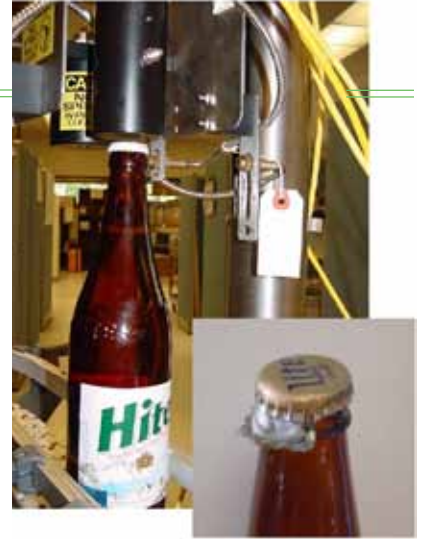
▲ A beer bottle passes under the inspection station of the T500-AC. The inset shows a crown defect.

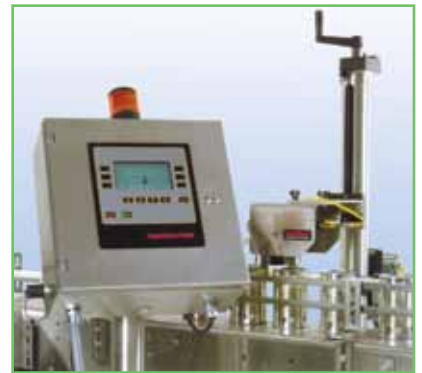
▲ TapTone 500-A Acoustic Sensor

The T500-A uses acoustic technology to measure pressure in beer bottles that do not have a measurable lid deflection. The acoustic sensor works by applying a "tap" to the top of each container. The "tap" is produced by a large electromagnetic pulse, which excites the container lid. The lid vibrates at a natural resonant frequency "tone" based on internal pressure. The resultant "tone" signal is sensed by a microphone, digitally sampled and stored in memory for processing. The Digital Signal Processor (DSP) produces a real-time signal spectrum and calculates the resultant frequency of the "tone" for that container lid. This frequency value is then compared to user set limits where containers with a frequency response outside these limits are rejected.

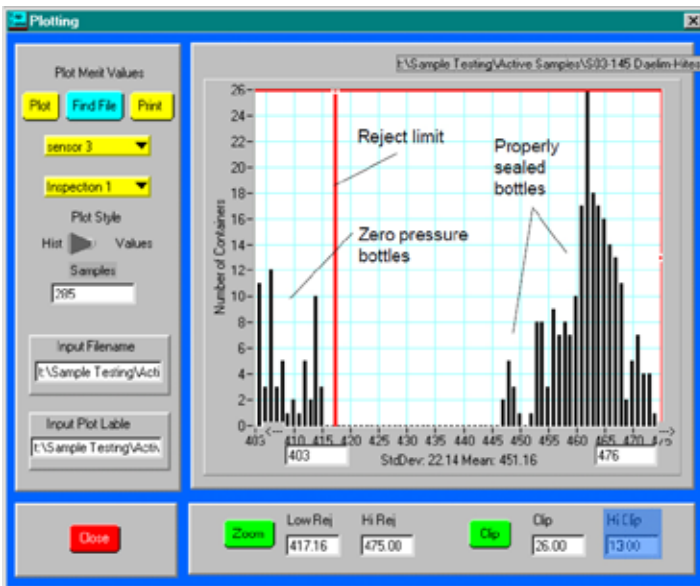
For this application review, five glass beer bottles with metal crowns were repeatedly tested on a loop conveyor running at high speed. One bottle was made to read zero pressure. The T500's acoustic head and photo triggers were adjusted per the application requirements. The data plot below shows that the T500-AC can easily distinguish between the sample bottles tested. A difference of 47 merit values between

low pressure and properly sealed bottles will allow the operator to set up parameters for rejection of defects.

The test clearly shows that bottles with a loss of pressure or defective caps can be identified using the TapTone 500-AC.

NOTE: Merit value is a calculated number generated from the processing of an algorithm to compute a resultant from a set of data values.

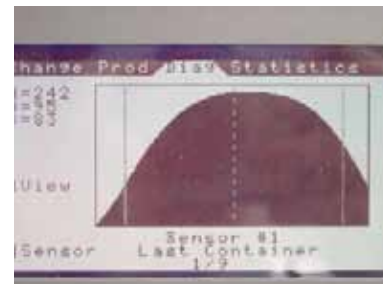
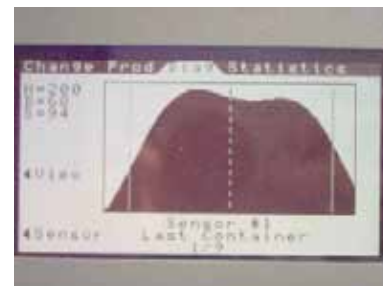
▲ The top profile shows an undamaged crown. The bottom profile shows a dented crown. Crown defects can clearly be identified using the T500-AC.

The cocked crown detector is an optional sensor for the T500-A to increase the detection and rejection of damaged crowns. It works by measuring the crown curvature with an analog proximity sensor and comparing it to the curvature of a good crown. If the detector determines that the measured crown is outside of a predefined set of criteria, a reject signal is sent to the T500 controller to remove the bottle from the production line.
